Manhole Inspection Summary

Manhole # S63M__001MH

Insp Date: **4/25/08 11:00 AM**

Location Address: **5501 O'Donnell St.**

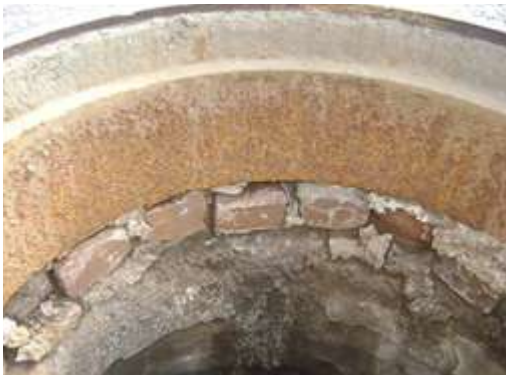
Defect 2

Condition: ☐ Sound ☐ Cracked ☐ Root Intrusion ☒ **Loose Brick** ☒ **Deteriorated**

loose bricks and mortar at frame adjustment

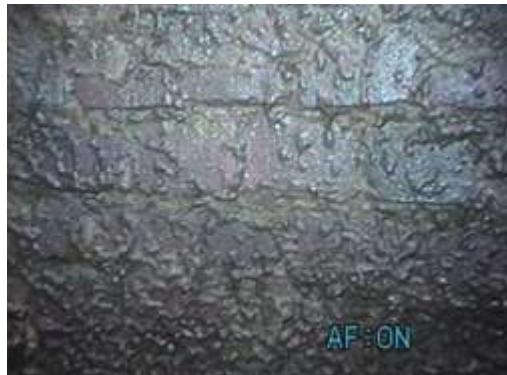
Defect 3

Infiltration: ☐ None ☒ **Joint** ☐ Cracks ☒ **Mortar** ☐ Roots ☐ Wall

Infiltration

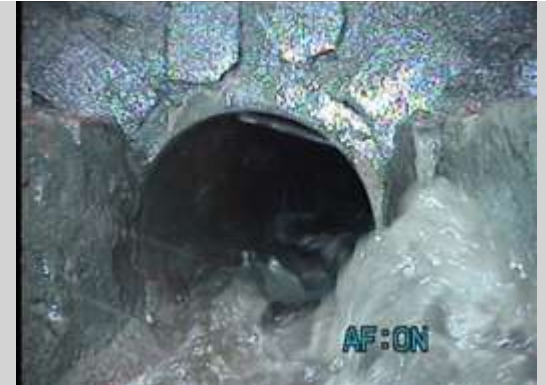
12 O'Clock Outflow

Pipe Height: **8.4** (in.) Rod and Bar (Angled)
Pipe Material: **Clay** ☐ Pipe Lined
Invert Depth: **10.75** (ft.) Flow Characteristics: **Fast**
Deposits: ☒ None ☐ Mud ☐ Sludge ☐ Debris ☐ Grease
Silt Depth: (in.) Deposits Extent:
Infiltration: **None** Pipe Seal Cond: **Sound**

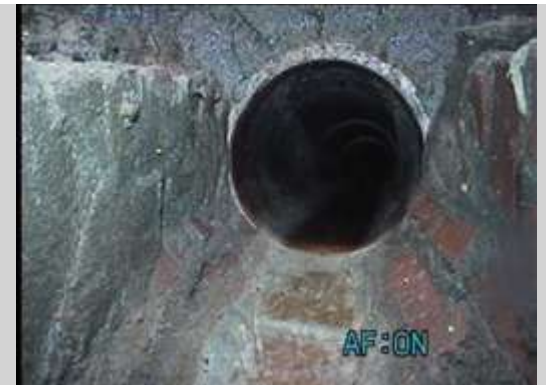
6 O'Clock Inflow

Pipe Height: **8.4** (in.) Rod and Bar (Angled)
Pipe Material: **Clay** ☐ Pipe Lined
Invert Depth: **10.33** (ft.) Flow Characteristics: **Fast**
Deposits: ☒ None ☐ Mud ☐ Sludge ☐ Debris ☐ Grease
Silt Depth: (in.) Deposits Extent:
Infiltration: **None** Pipe Seal Cond: **Sound**

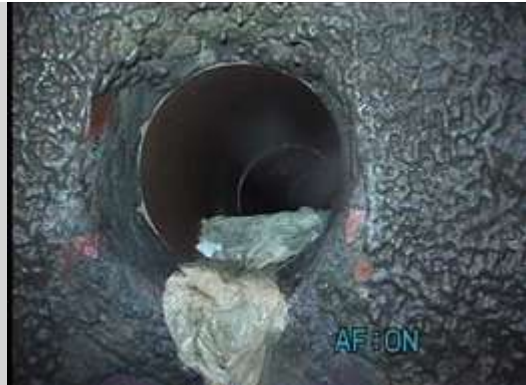
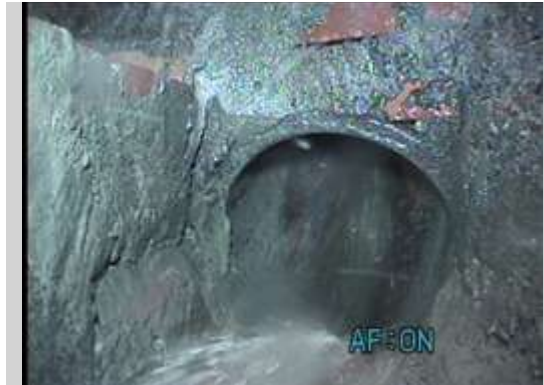
9 O'Clock Inflow

Infiltration: **None** Pipe Seal Cond: **Sound**

Drop: **Outside** Rod and Bar

Drop Condition: **Open**
